**An examination into the use of the fauna  
passages, installed under the train tracks,  
by medium to small vertebrates**

A report submitted as the examined component of the Project Module SXE390

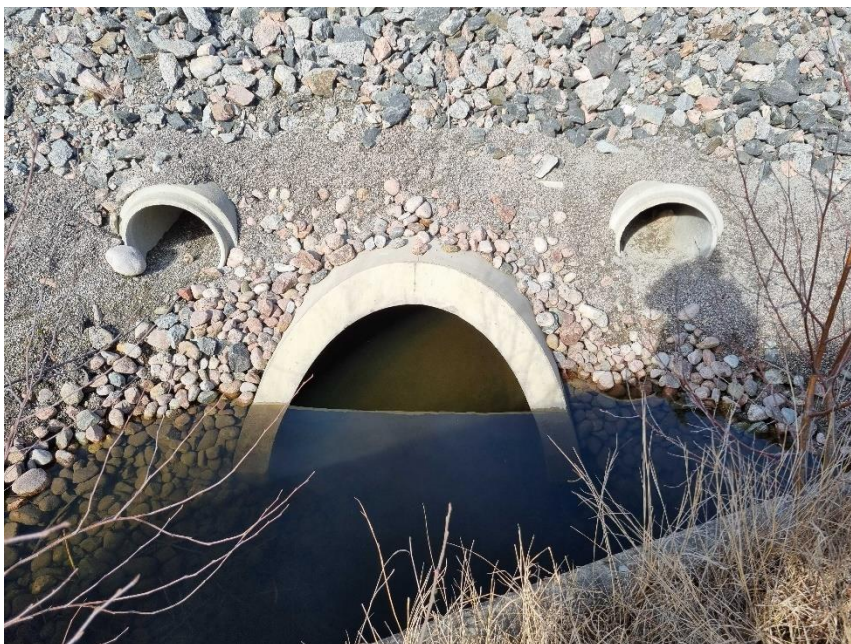
When the culvert was renovated the Trafikverket ecologist suggested 2 ecoducts be included (one on each side of the main culvert) at the same time, as it would entail relatively little extra costs. The culvert comes out in a small collection area and then there is a second culvert going under the service road, before returning to a free-flowing stream (See figure 5). The ecoducts are 60cm in diameter.

**Figure 5 Picture of the ecoducts alongside the culvert at Ullnaån**

The camera is placed a little to the left of the above picture (figure 5), at an angle so that all three, two ecoducts and culvert, are captured (see figure 6).

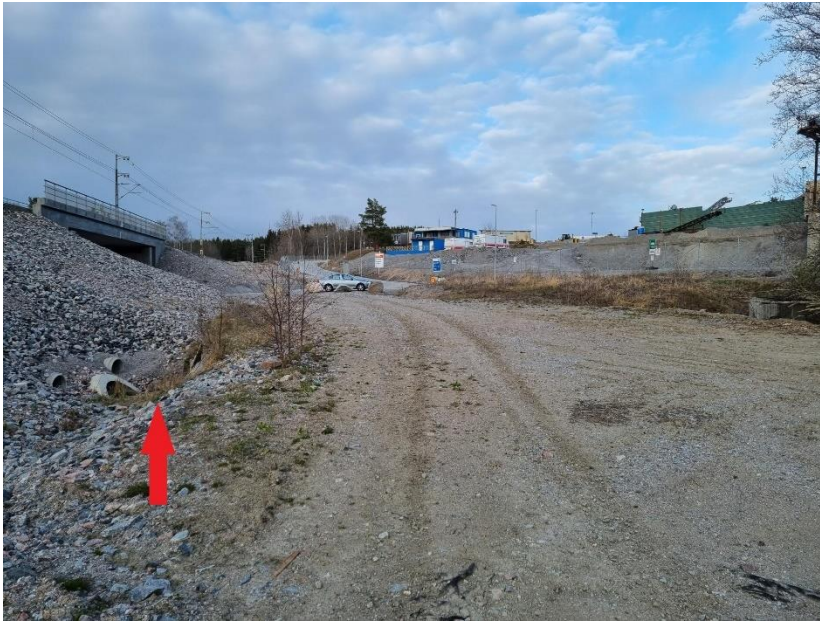
**Figure 6 Picture of the camera position at Ullnaån**

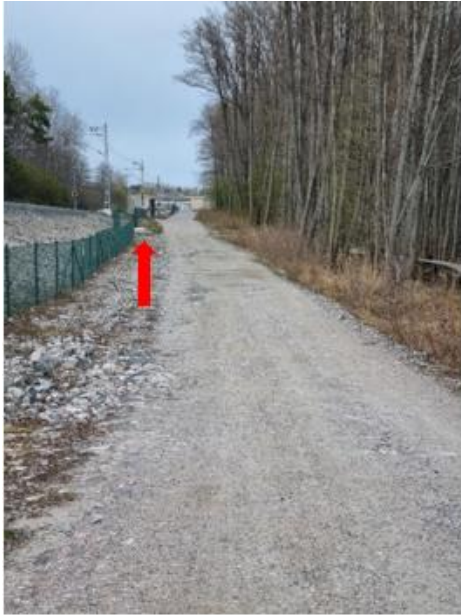
There is a gravel access road alongside the train track that is very well used by the locals for walks, and a marshy area on the other side of this road (see figure 8).

**Figure 8 Picture of the position of the ecoduct at Täby prison**

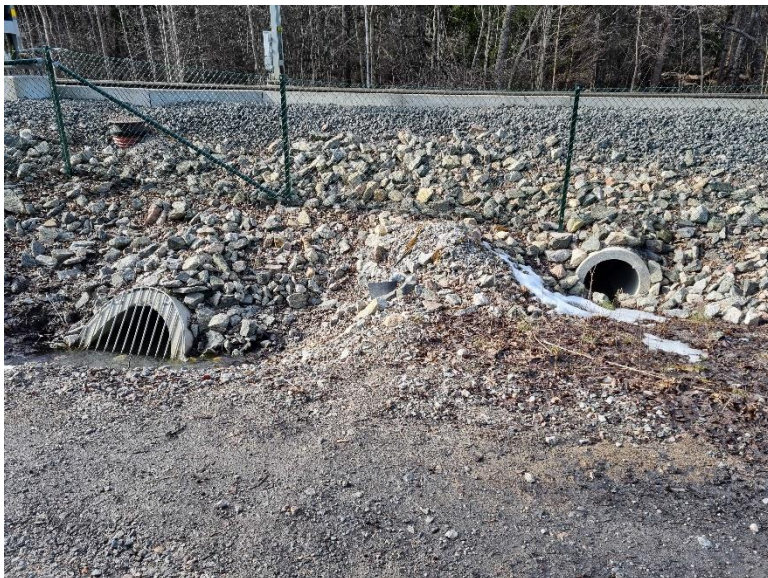
For this reason it was decided (on the advice of the Trafikverket ecologist and later confirmed by Fagart et al, 2016) that the camera actually be placed inside the tunnel (hanging from the roof, see figure 9). The other side of the road would be very noticeable to people who may disturb the camera and also much harder to pick up signs of small animals at a 5m distance. This ecoduct is also 60cm in diameter.

**Figure 9 Picture of the ecoduct outside Täby prison, with culvert to the left**

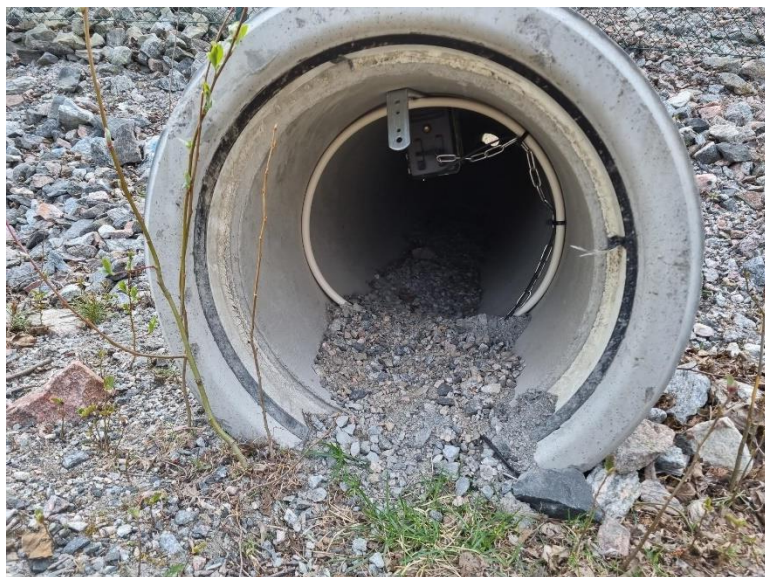
**Figure 10** Picture of the camera positioned inside the ecoduct

The cable is to a large external battery and the chain is to reduce the risk of theft (see figure 10). The gravel was already placed inside the ecoducts on construction and was added to cover up the cable and chain as much as possible.

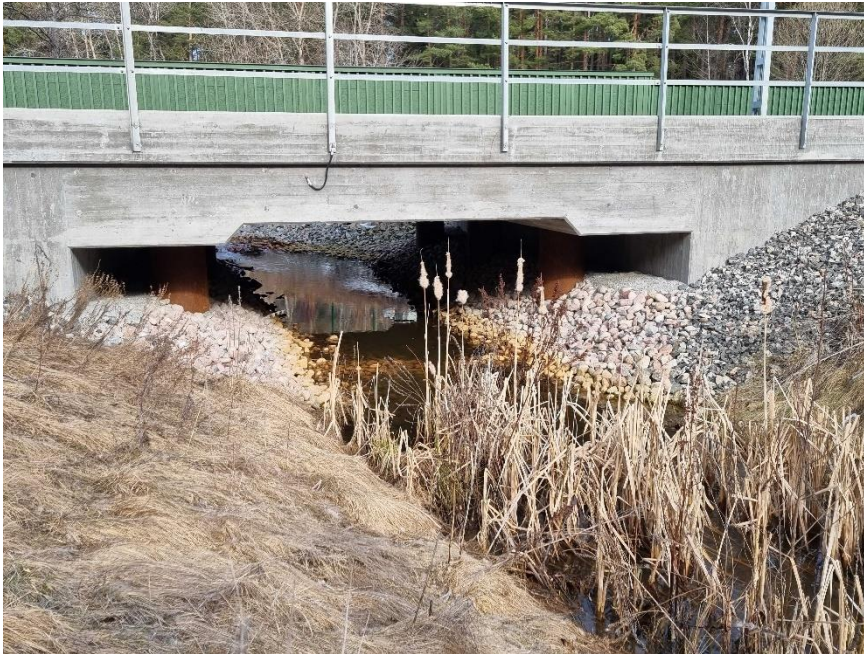
When renovating the tracks at Hägernäs station it was decided to replace the bridge under the tracks with another design incorporating “shelves” at the side allowing passage for animals (see figure 12), following the guidelines referred to above.

**Figure 12** Picture of the ecoduct at Hägernäs station

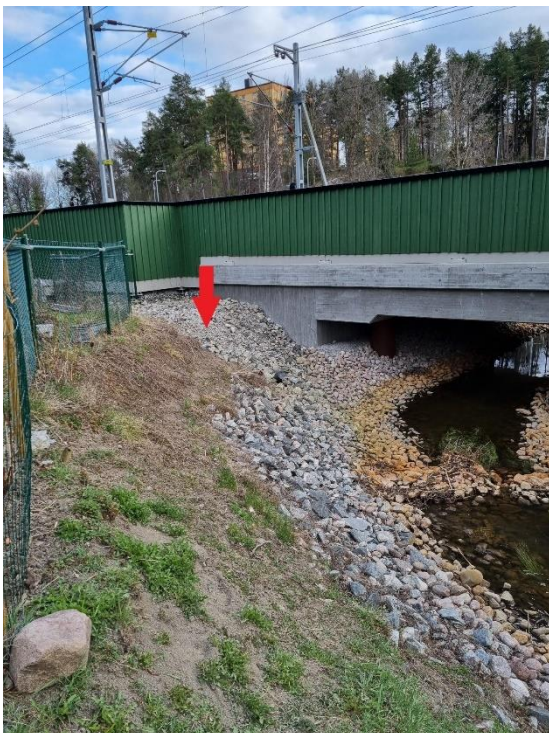
The camera is placed on the opposite side of the tracks, in this picture, and angled to capture both sides of the bridge (see figure 13).

**Figure 13** Picture of the camera position at Hägernäs station

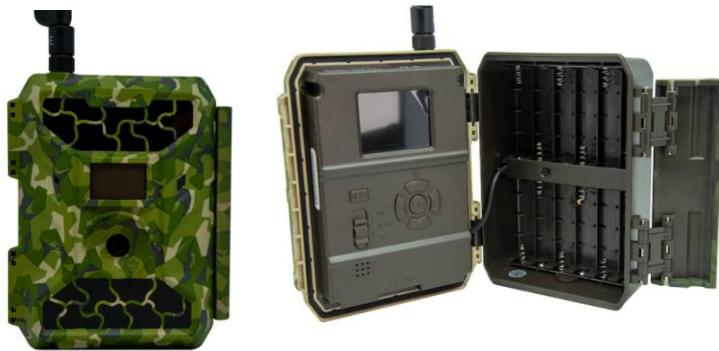
The cameras used are Pro-Optics PRO 3.4G (see figure 14) and were initially configured to take a picture once every 30 seconds (following recommendation made by Pomeranzi, 2017, Jumeau et al,

**Figure 14 Trail camera, Pro-Optics PRO 3.4G**

The cameras have a lens width of 51' so a cardboard triangle was formed to help with aiming the camera as it is not possible to see the picture once the camera is closed.

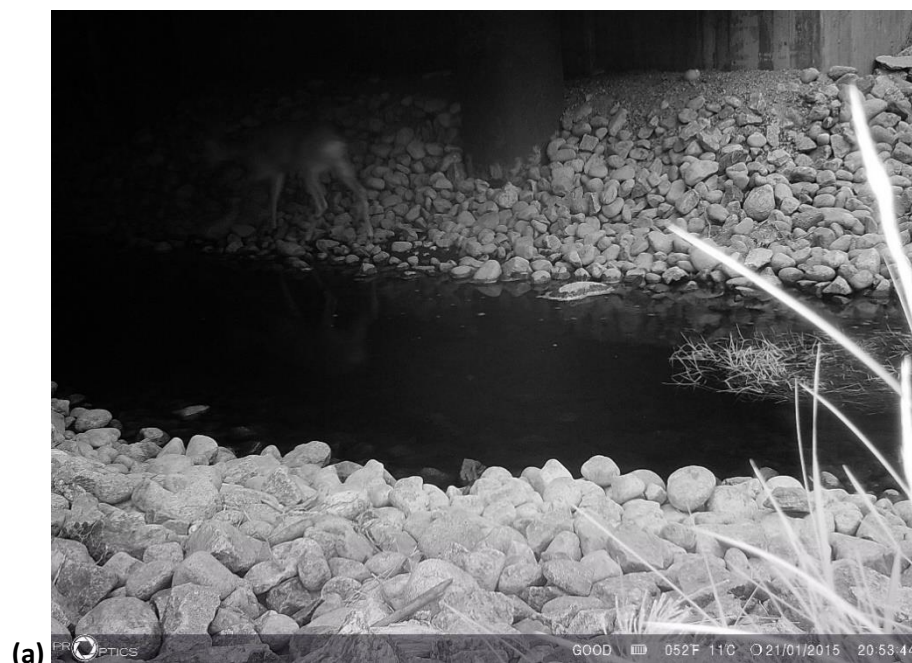
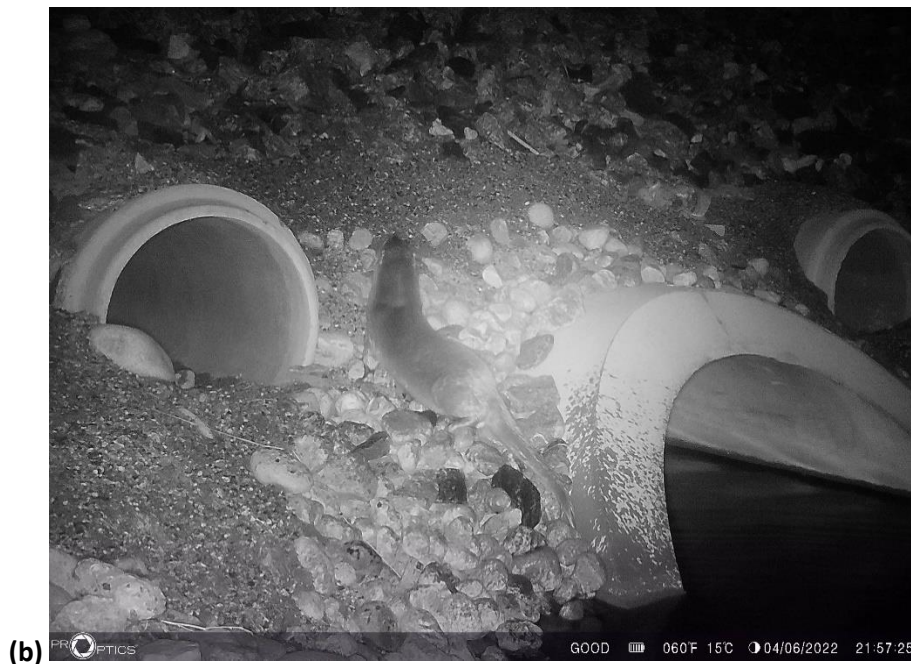
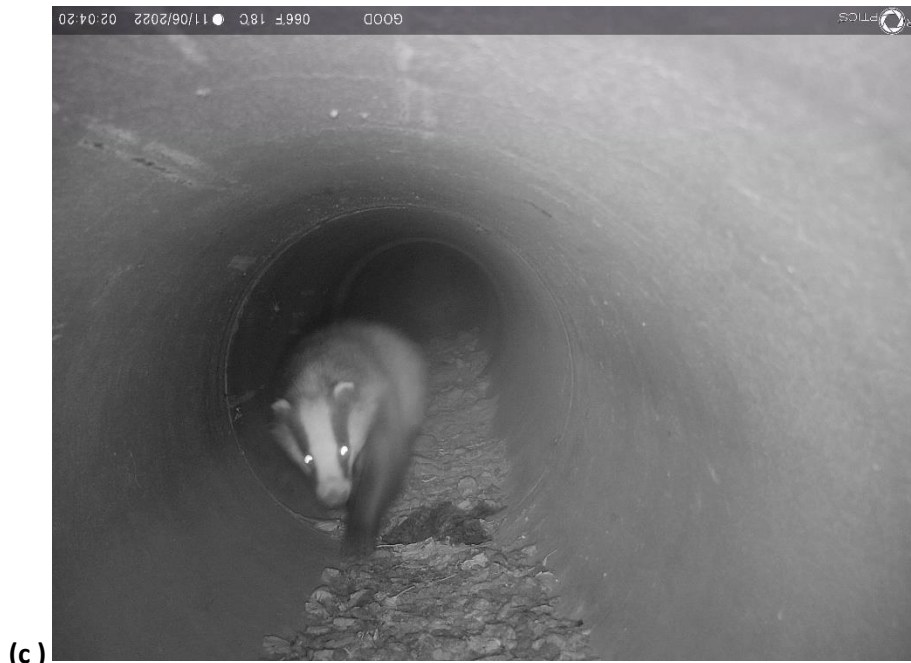
**Figure 15 Sample of images captured at the different sites**

a. A roe deer (*C. capreolus*) at Hägernäs b. An otter (*L. lutra*) at Ullnaån c. A badger (*M. meles*) at Täby Prison

(Note that the camera was hung upside down in the tunnel at Täby Prison so the images have been rotated).

Where identification was unsure but highly likely it was included in the species count rather than counted as “Unknown”. In addition, it was not always obvious whether a transit had taken place; this was a judgement call based on the position of the animal in the three consecutive pictures taken when the detector was triggered (see appendix for a brief discussion on this issue). Below (figure 15) are some examples of images captured.

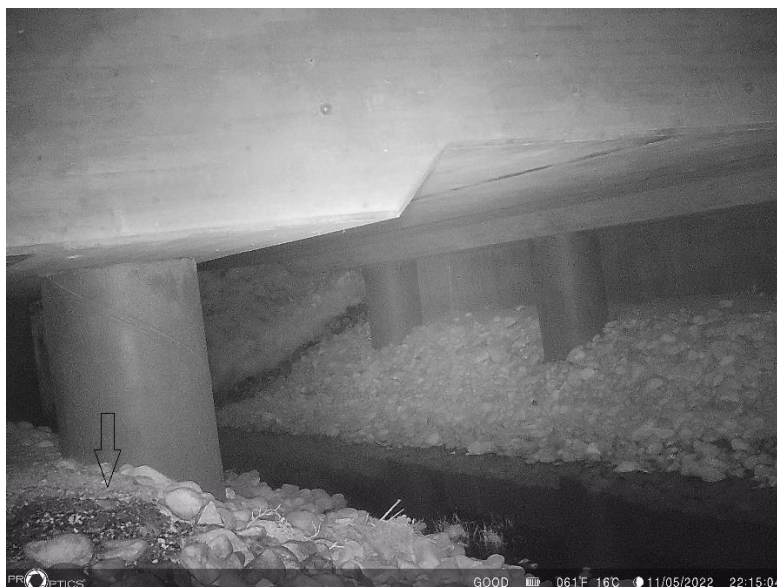
These trail cameras were sufficient to record images of medium sized mammals but failed to record any significant images of amphibians or small mammals, even when recording every 30 seconds. There were a few images with these smaller animals in but the species could not be identified, as can be seen in the example in figure 17.

**Figure 17 Hägernäs, Amphibian travelling up from water, unidentified species**

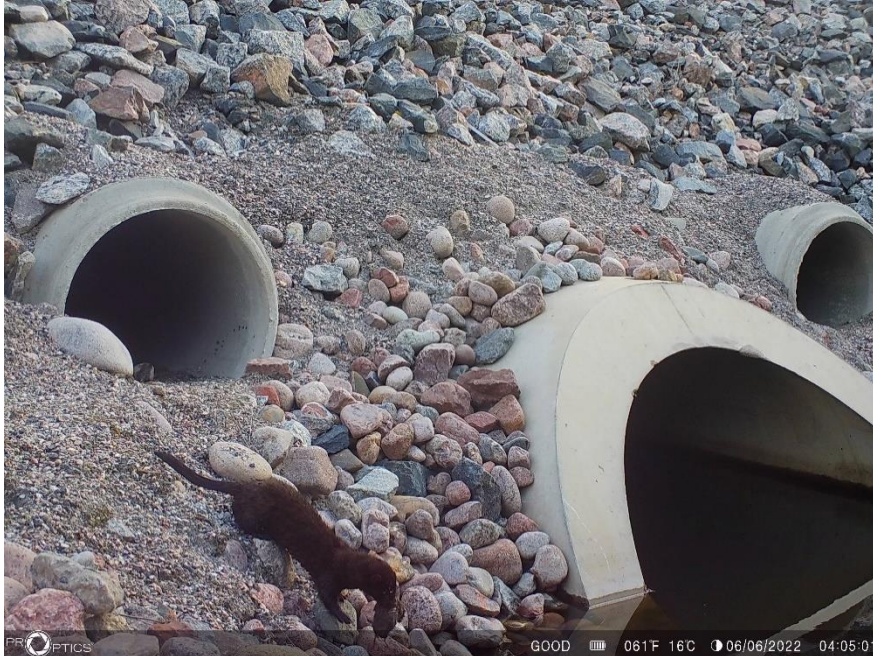
with a small mammal in its mouth (see figure 18). This may be because the motion detector is not fast or sensitive enough to capture them, in which case a different camera type needs to be used to study these animals. But it is also possible that small mammals are avoiding these fauna passages as they are used by their predators.

**Figure 18 Ullnaån, Mink (*Neovison vison*) with small mammal in mouth**

Of the small mammals only one rodent (species unknown and not using the passage) was recorded at Ullnaån however more smaller animals must be in the area as a couple of times a mink was recorded

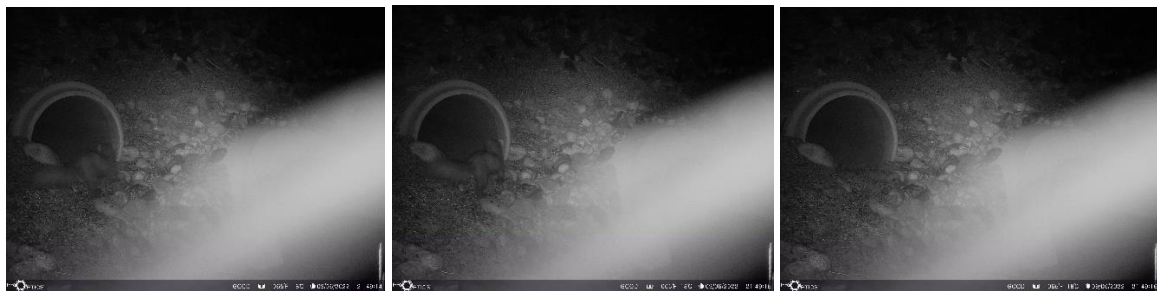
**Figure 19 Different types of fauna passages, reproduced from Fagert et al (2016)**

Roads and train tracks are barriers not just to finding a mate but also to finding food and shelter and get in the way of migration routes (Dyson, 2021). Some species cannot negotiate the tracks, others are scared away by the noise ((Barrientos and Borda-de-Água, 2017) and many of those that can traverse the barrier may fall victim to collisions with vehicles (Helldin & Petrovan), all of these effects are depicted in figure 1, below. These issues have led to the idea that corridors should be created to connect these habitat fragments and for traffic infrastructure this has meant the introduction of ecoducts: bridges or tunnels crossing the roads and tracks, as standard practice during construction and renovation (note that throughout this report the term ecoducts will be used to cover all types of passages designed for wildlife traffic). The ecoducts’ design is based around animal size, the amount of light and the surface type (see figure 19 in the appendix for examples of different types of ecoducts).

(Note the passage type definitions used are from Fagert et al, 2016 and shown in figure 19 in the appendix).

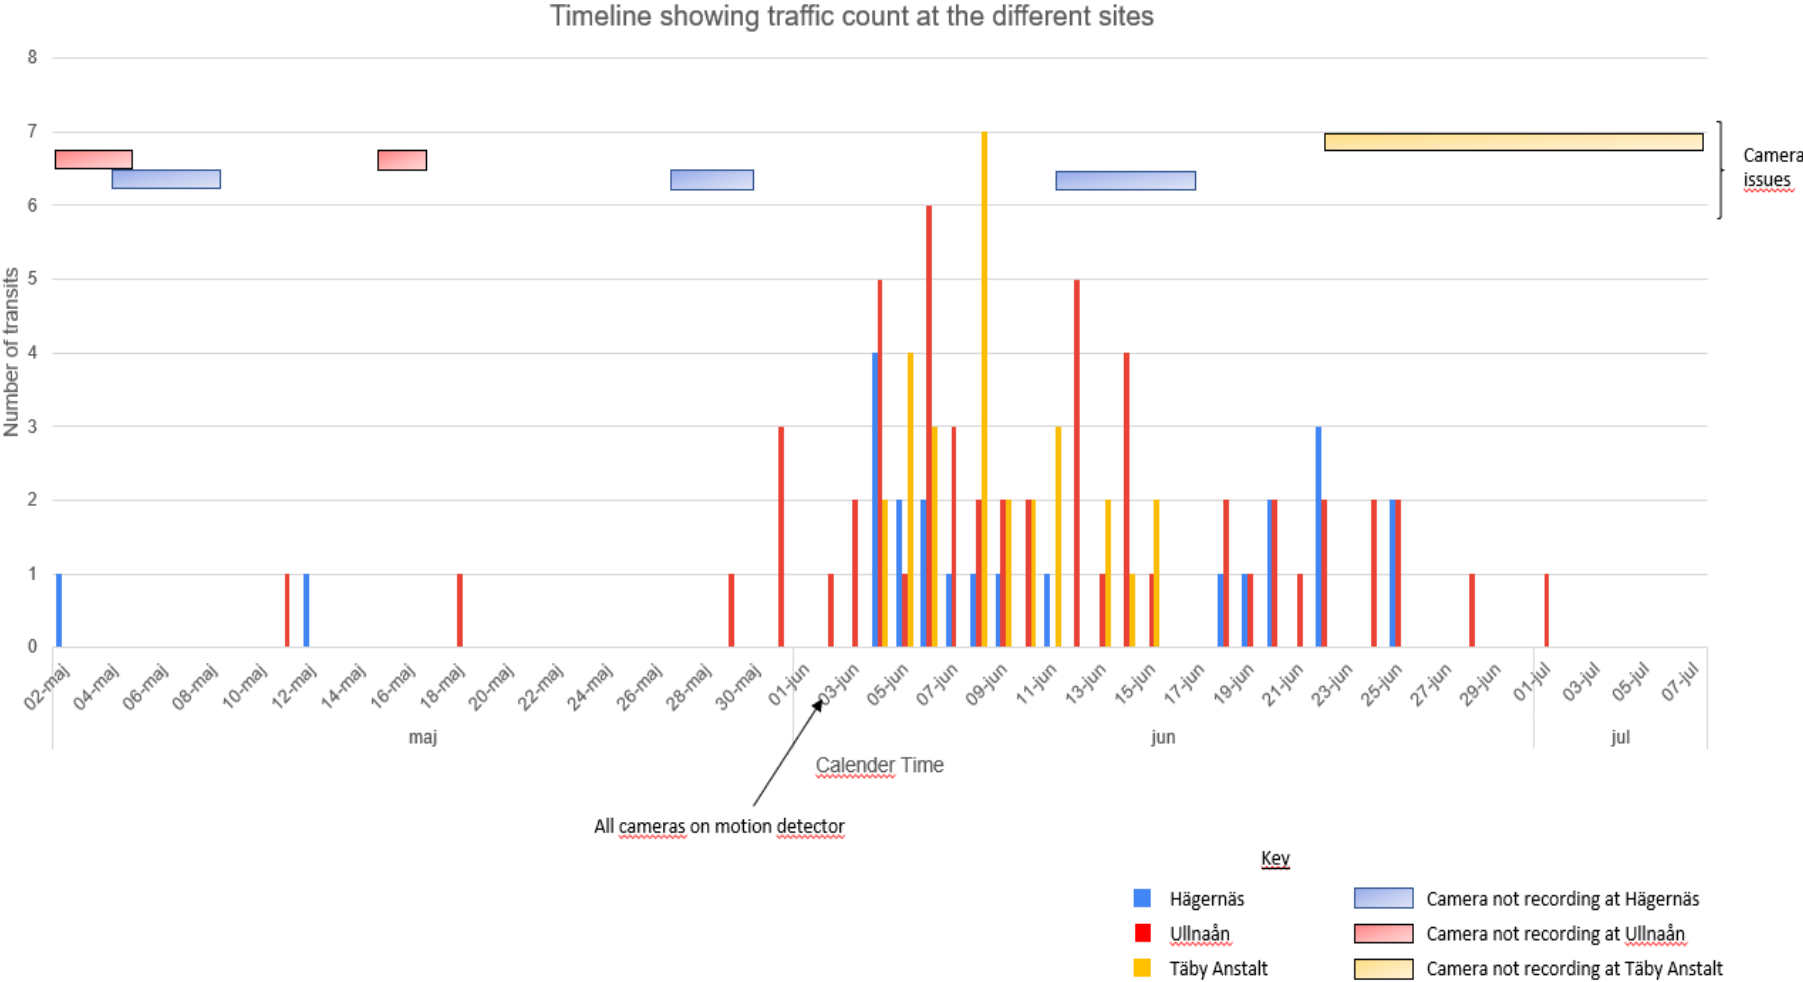
Figure 20: Transits at all sites, across time, also showing where issues hindered the collection of images

An examination of the timeline (see figure 20 in the appendix) for all data captured clearly shows that the number of transits captured increased when the camera configuration was changed to motion detector. Some of the capture failure can be attributed to technical problems such as battery failure, the SD card being filled up, or the camera being knocked over. However, there is a week (prior to the theft) at Täby Prison where no transits were captured and which cannot be explained by technical issues. It appears that animals failed to use the passage at all during this time and there is no obvious explanation for this, it could be simply that the badgers have been moved on or run over on the motorway.

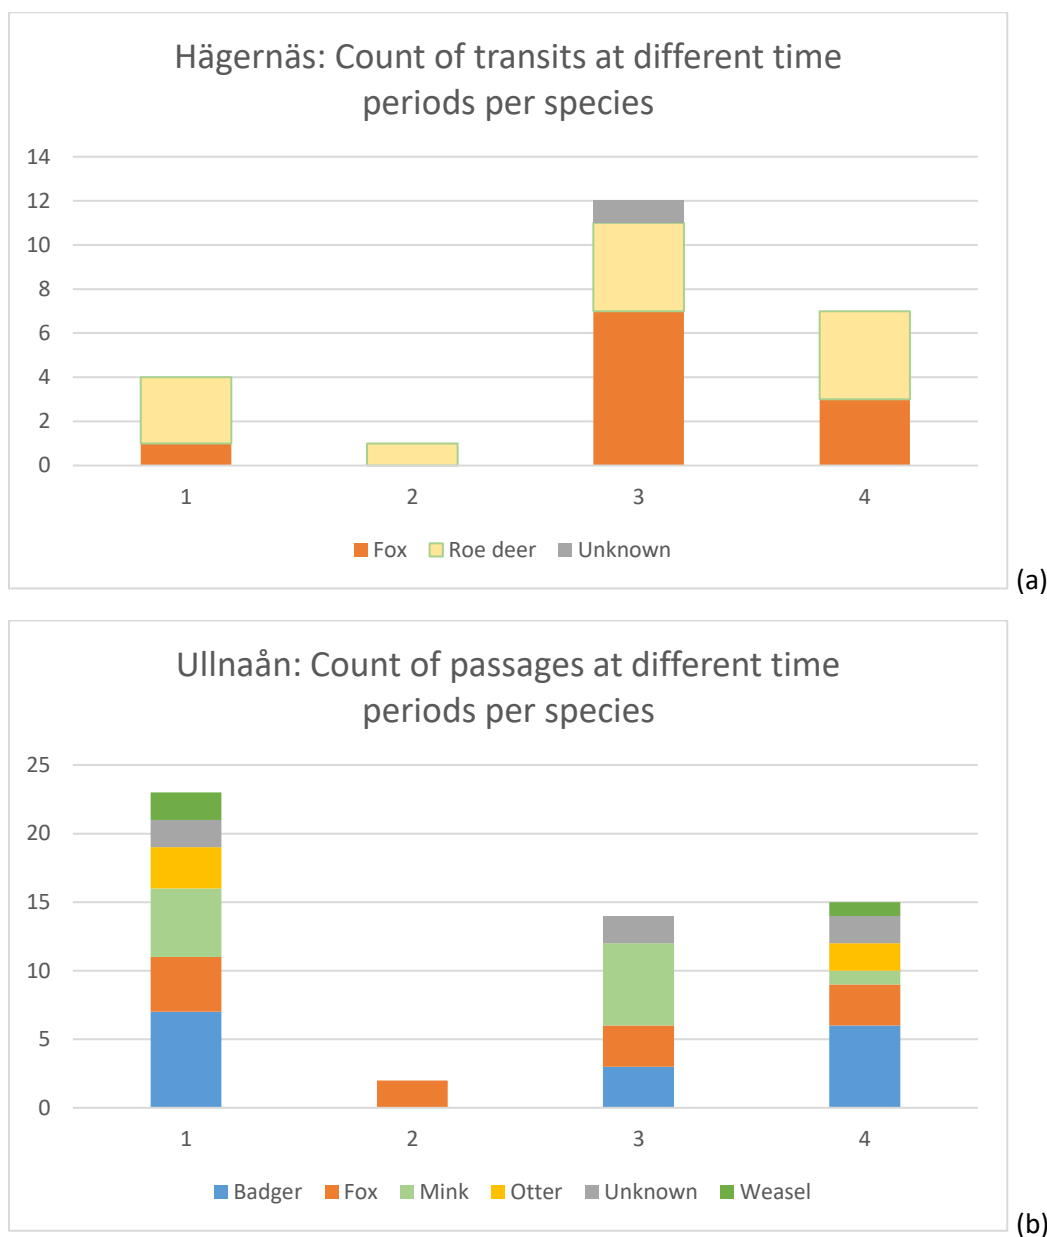
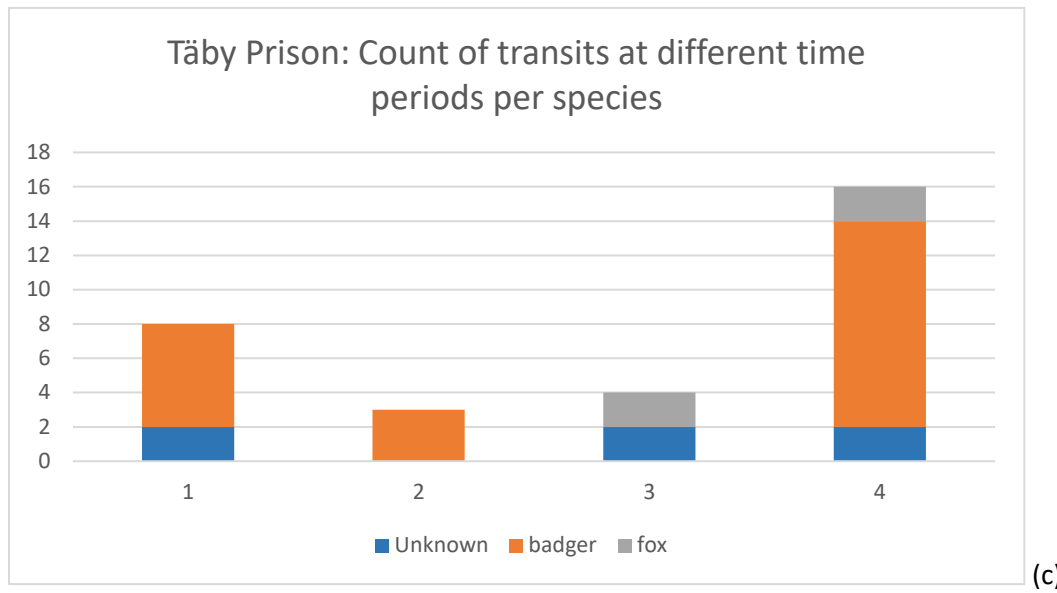
**Figure 22** Counts of transits at different times of the day for different species, 1: midnight to 6am, 2: 6am to noon, 3: noon to 6pm, 4: 6pm to midnight. (a. Hägernäs b. Ullnaån c. Täby Prison)

A simple analysis of the data shows that, in figure 16 below, very few transits are recorded between 6am and 12noon. Otters seem to prefer the late evening and early morning, whereas foxes appear to travel throughout the day. (See figures 21 and 22 in the appendix for more details).
